Manhole Inspection Summary

Manhole # S21K1_002MH

Location Address: **3024 stranden rd**

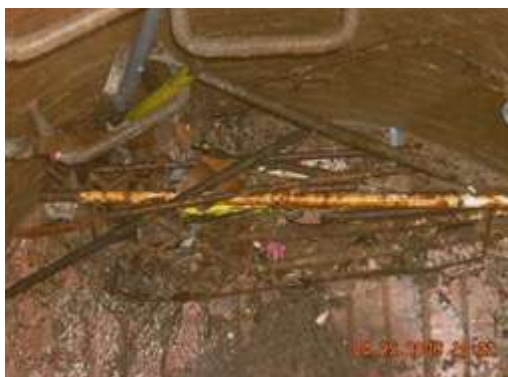
Defect 4

Condition: ☐ Sound ☐ Cracked ☐ Root Intrusion ☐ Deteriorated ☐ Leaks ☒ **Debris**

debris on bench

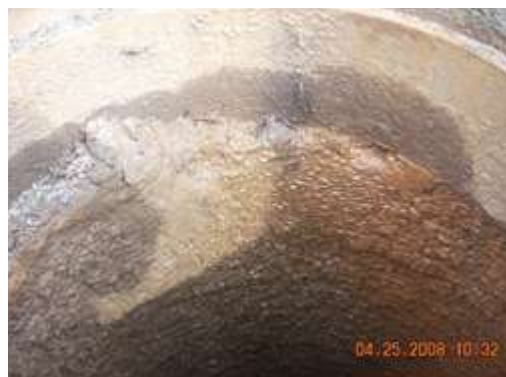
Defect 3

Infiltration: ☐ None ☒ **Joint** ☐ Cracks ☐ Mortar ☐ Roots ☐ Wall

infiltration @ corbel/chimney joint

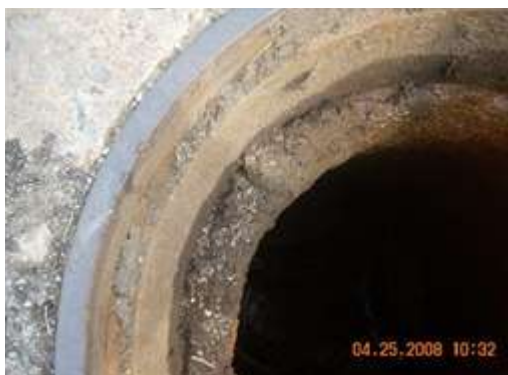
Defect 2

Offset: **2** (in.)

frame offset

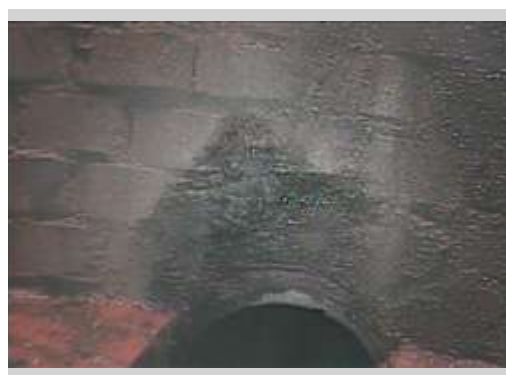
Defect 1

Infiltration: ☐ None ☐ Joint ☐ Cracks ☐ Mortar ☐ Roots ☒ **Wall**

infiltration @ barrel wall above 9 o'clock

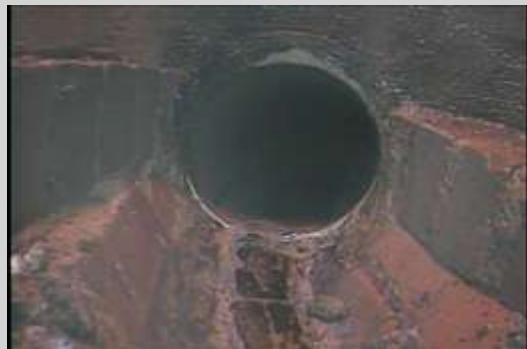
9 O'Clock Inflow

Infiltration: **Evidence** Pipe Seal Cond: **Unknown**
